NATIONAL REGISTER OF HISTORIC PLACES REGISTRATION FORM

historic name: Smith Mine Historic District

city/town: Bearcreek

state: Montana

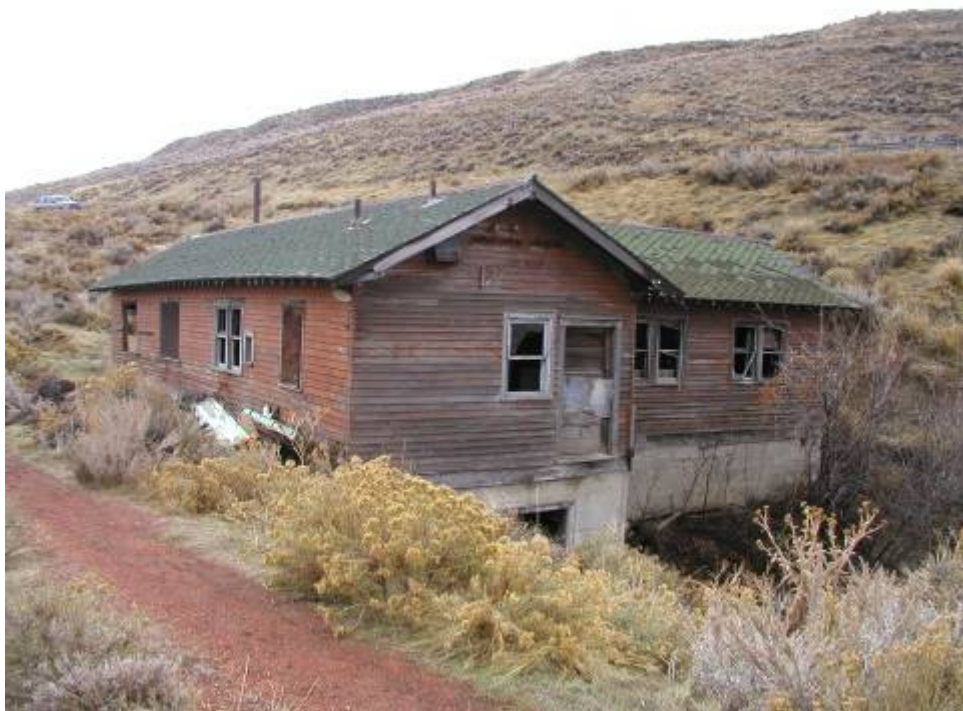
This one-story wood frame L-shaped gabled roof building is located in the southeast corner of the site. This residence straddles the coulee and sits south of the two-track road that accesses the site. The building rests on a high concrete foundation and measures 52' by 16' with an intersecting gable measuring 24' x 6.' It is believed this building was the manager's residence.

All gable roofs are covered with both deteriorating scalloped asphalt shingles and rolled roofing. The main east/west gable has a metal ridgecap with end finials. Roof details include extended exposed rafters and several protruding stove pipes. The roof extends over all gable ends and exhibits curved brace supports accented with pyramidal ends.

All exterior walls are clad with narrow lap siding that extends into the gable ends. Metal clips finish all corners. An exterior baseboard with a protruding lip (water table) separates the concrete foundation from the wall.

The west gable end holds an entry with a five panel solid door (missing several panels) and a one-over-one double-hung window immediately adjacent to the door. A platform, porch or stairway that would have fronted the door and allowed egress/ingress to the building is missing. The east end wall holds the primary entrance although the door itself is missing. To the south (left) of the door is a one-over-one double-hung window presently boarded over with plywood. There is a framed square opening in the apex of the gable end (presumably for a vent).

The north wall contains four window openings across its length, including one paired one-over-one double-hung, two one-over-one double-hung that are boarded shut, and one opening missing its window unit. The south wall has paired one-over-one double-hung windows missing all glass panes, and one boarded shut window.

Photo No. 0003. Manager's House (1), view to southeast

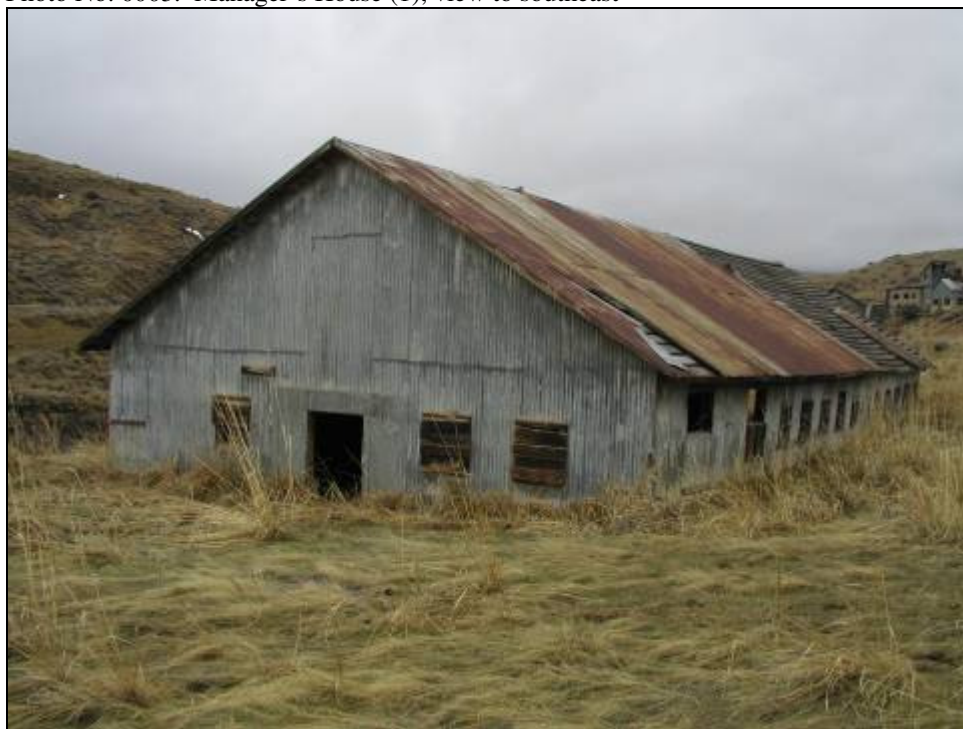
The car repair shop, built in 1913, originally functioned as a carpenters shop until 1924 when the company designated it for use as a warehouse. In 1930, it became the car repair shop. Mine cars damaged during the transport of coal were repaired in this building.

The farthest building to the east at the Smith Mine, the car repair shop measures 38' x 115' and has no discernable foundation. The wood-frame rectangular plan building is covered by a gable roof. The roof is deteriorated with sections of the original corrugated metal missing revealing the wood decking underneath. The rafter ends have been boxed in.

A bay entry is central to the west façade of the building. It had a door (now missing) mounted on exterior wood tracks. A small man-entry is located on the south façade. It has a vertical tongue-in-groove door that is partially detached from the hinges. A bay entry is central to the east façade. A window opening is located to the south of the bay and two window openings are located to the north of the bay; all are boarded over.

Photo No. 0004. Car Repair Shop (2), view to west

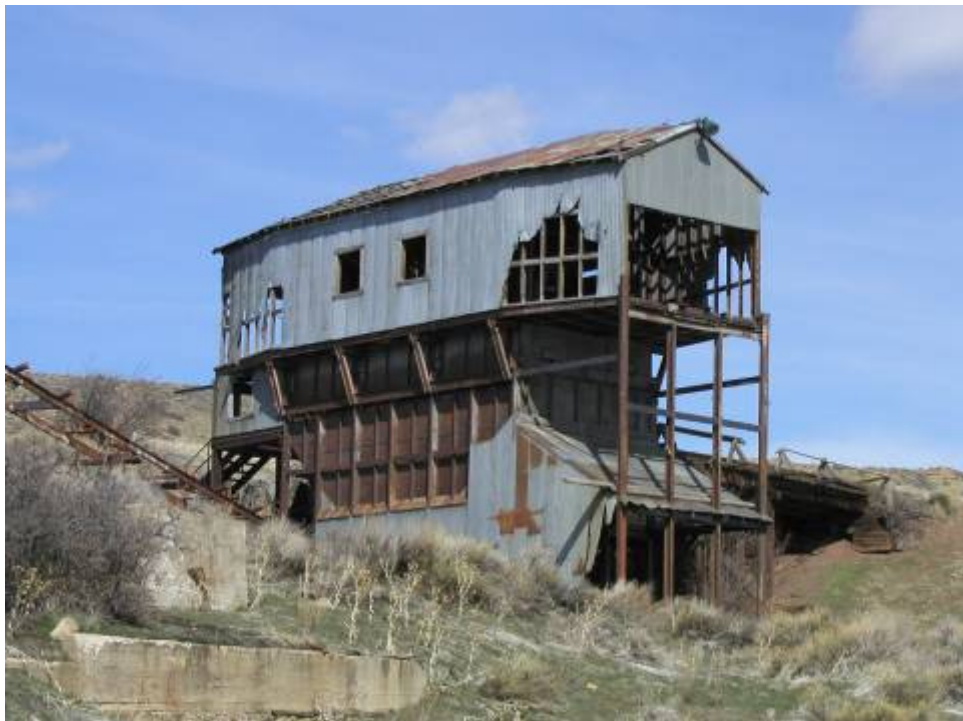
The tipple's overall shape is rectangular and is topped with a wood frame gable roofed head house. This head house overhangs the hopper structure on three sides. It is covered with corrugated metal on the walls and roof (sections missing). It has two framed window openings on the east and west side walls. The north end is open to allow passage of rail cars into the rotary dump. The south end is also open where it previously connected to the more extensive tipple.

Photo No. 0007. Tipple (5), view to north/northeast

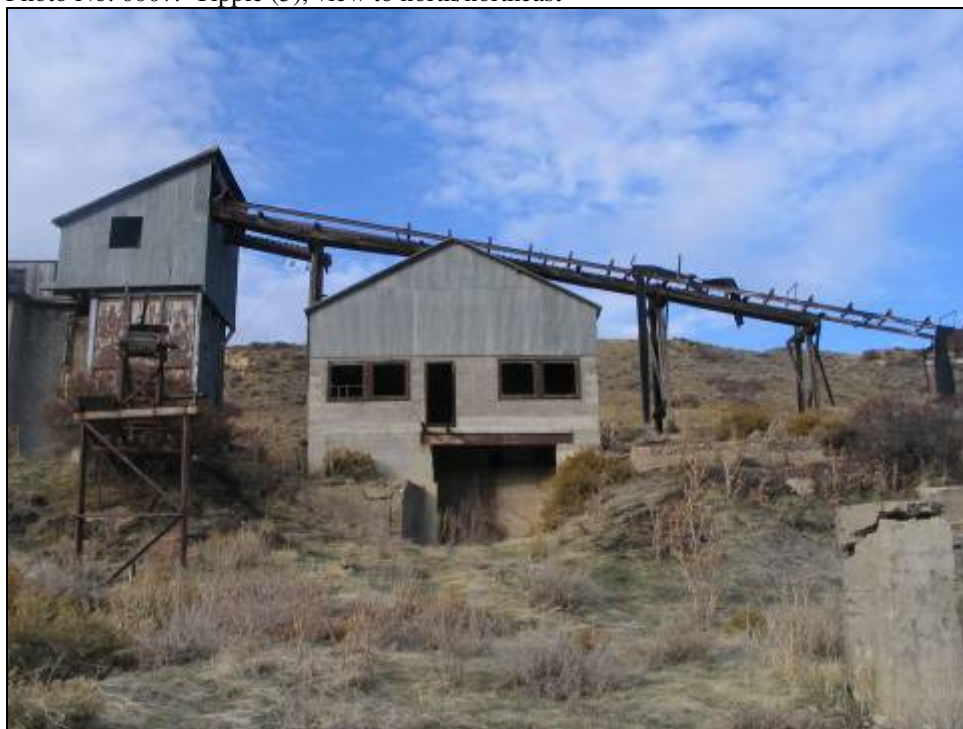
A double conveyor belt extends from an opening in the south wall of the coal processing plant (Building 7). The dual conveyor belts allowed for simultaneous loading of railcars. The paired conveyors exhibit only their flared iron supporting idlers and are missing their belts. The conveyor is supported on vertical steel I-beams that rest on concrete pyramidal piers.

Photo No. 0008. Conveyor (6), view to north

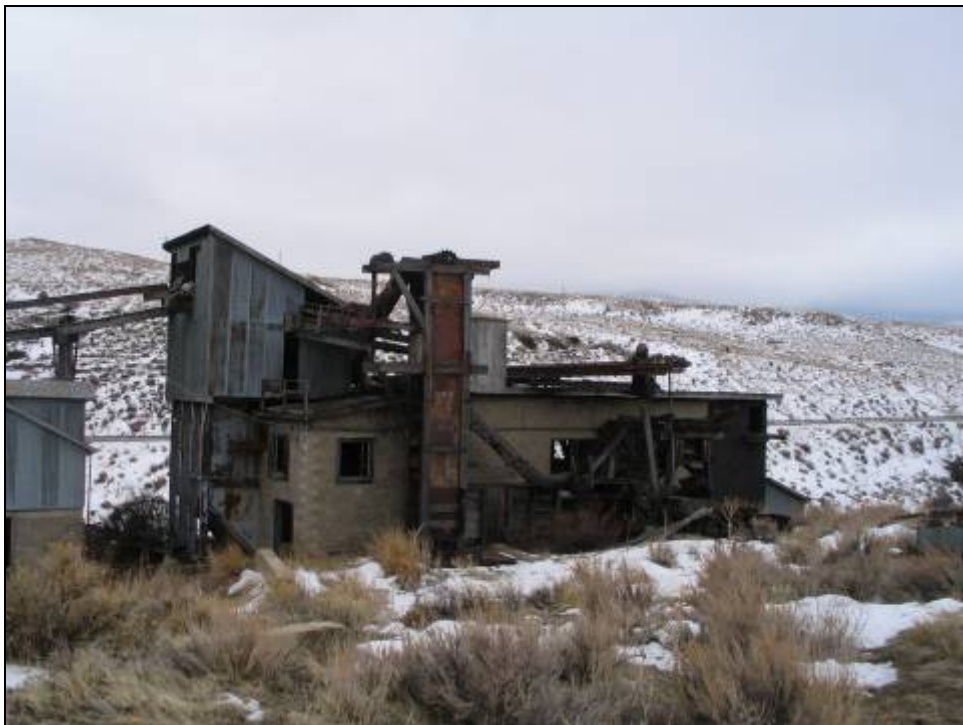
The coal processing plant may have first been built in 1928 and remodeled in 1933. The building was badly damaged in a fire in 1946 and rebuilt to its present configuration that year. The shaker screens and other equipment involved in the coal separation process are still located in this building. Coal slack was also removed from the coal at the plant and deposited in piles that were once located to the east/northeast of the plant (they were reclaimed in 1990). The building is oriented east and west and is the center of the mine's above-ground operations.

The coal processing plant has a poured concrete foundation and the walls of the primary structure are comprised of concrete blocks. The building has a combination shed and flat roof that is sealed in asphalt. There are window openings on the north and south walls. A small vertical opening is located between the window openings on the north wall and an entry is situated on the west. A small wood

frame structure is located on the northeast corner of the roof. It has corrugated metal siding and metal sheathing over the shed roof. There is a metal conveyor belt frame projecting from the structure to the northwest. The structure opens to the east toward the tipple. The roof between the structure and the tipple at the northeast corner has a duckboard floor and wood railings. A badly deteriorated duckboard cat walk is located adjacent to the conveyor on the south. The structure is associated with a tipple on the east end of the structure. The east end of the building has window openings on the east and north walls. The window frames indicate they once had single fixed lites flanked by three fixed lites on either side. An entry pierces the foundation on the east of the north wall. It has a wood paneled door.

A flat roof addition attached to the west end of the building also functioned as a tipple. Vehicles backed into the structure and coal was unloaded from the tipple into the vehicle. The addition has steel walls supported by steel I-beams which rest on a concrete foundation. The bay entry opens to the west. The tipple is comprised of sheet metal with a steel I-beam frame. Some of the I-beams are in poor condition. The addition rests on a concrete pad, while the I-beams are supported by concrete piers. There is an opening on the upper west corner of the north wall. A duckboard platform projects from the opening. There is no window or other openings on the south wall of the addition. A small corrugated metal addition is attached to the west wall. It has a bay entry with two vertical wood doors with vertical braces.

A loader is attached to the east end of the building. It is vertically oriented with a shed-roof man-house located at the top. The main frame is comprised of vertical steel I-beams that were manufactured by Bethlehem Steel at an undetermined time. The bases of the I-beams rest on concrete piers and there is a concrete foundation underneath the load-out chute of the frame. The frame itself is comprised of sheet steel supported by steel railcar tracks. The tracks are not industrial size indicating they may have been salvaged mine tracks. The tracks were manufactured by Illinois Steel Company South Works, a company based in Chicago, and stamped "7201." The rail tracks are welded to the vertical supports.

The frame empties onto a steel frame conveyor system that extends to the southeast. The conveyor is comprised of steel channel sections and angle sections with rollers; the southeast end of the conveyor rests on a concrete pier foundation. The conveyor extends out over a bluff and possibly emptied onto a railroad siding. The man-house is comprised of a wood frame sheathed in corrugated metal with a window opening on the south wall and an entry centrally located on the rear (west) façade. The entry leads onto the roof of the main processing plant. The roof has exposed rafters and swallows have built nests under the eaves. The man-house has a wood floor. The east wall of the tipple has an opening to allow entry of the conveyor belts from the big tipple to the east (F-5).

A vertical bucket chain conveyor system that has partially collapsed is located near the northeast corner of the structure. The structure is wood frame and rests on a concrete foundation. The conveyor is connected to the conveyor systems on the roof of the main building. The buckets either collect or empty from or into a concrete-lined pit adjacent to the structure on the north.

Photo No. 0009. Coal Processing Plant (7), view to south

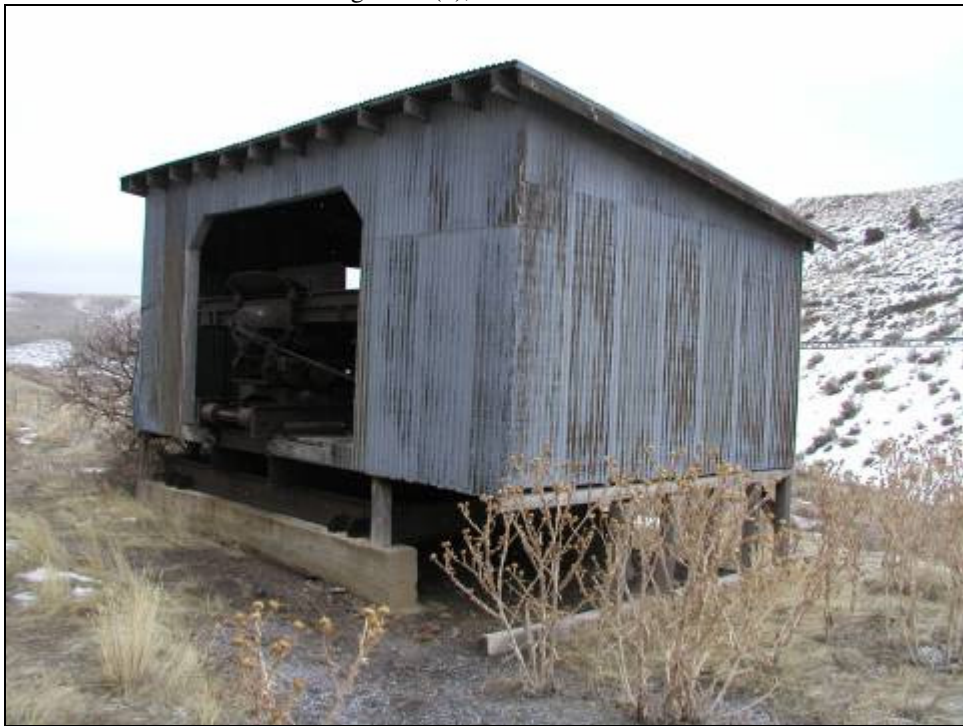
The scale house is located south of the west section of the coal processing plant (Building 7) and box car loaders (Building 4). The building was constructed in 1930 to house the scales that had been on-site since sometime between 1906 and 1909. The scales were replaced in 1935 and placed on a new foundation in 1956. It is oriented north and south and faces north toward the boxcar loaders (Building 4). The building rests on steel I-beam foundation with I-beam stringers that are supported by concrete piers. The wood frame building has a shed roof. The roof and walls are clad in corrugated metal. There is a large bay entry on the façade that reveals the steel weighing machinery inside the building. On the south wall are two window openings and a hole cut into the wall near the floor to accommodate the machinery inside the building. There is also an entry on the south of the east wall of the structure.

Photo No. 0010. Scale House (8), view to east

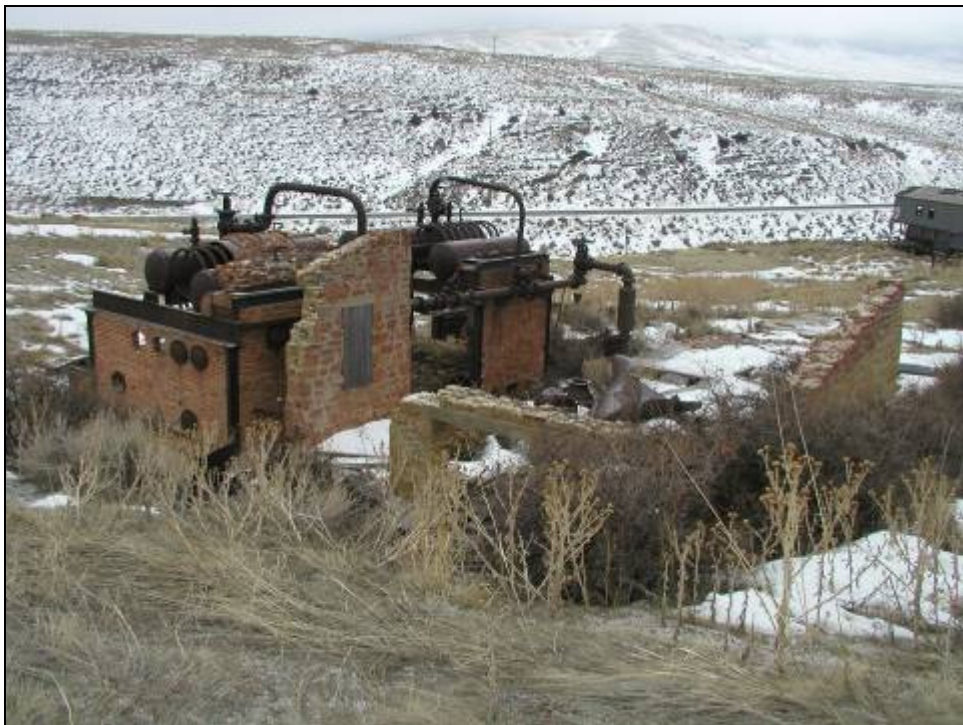
Situated northeast of the mine complex are the remains of the Power Plant originally built in 1914. Power plants generally were erected at a distance from the main operation for safety. MC&I built this power plant in 1914 after the Montana Power Company failed to honor an agreement to supply power to the Smith Mine. A 1916 historic photograph shows a large gable roofed building with two very tall stacks northeast of the building complex. The power plant burned in 1926 but was rebuilt and expanded. The 1927 Sandborn map shows a nearly square building covered with corrugated metal on its walls and roof. The wall construction incorporated wood framing, stone and brick. It is unknown when the MC&I stopped using this power plant, but by 1942, Montana Power Company provided electric power to the Smith Mine. Both the stone and the brick were locally made.

It appears that the power house was originally divided into two sections with the boiler house to the east. Two of three original water-tube boilers are still in place although components from each are missing. They were built on-site with all the components brought in. The steel plate boilers stand in a row along the east section of the power house. The boilers framework is supported by I-beams. The exterior brickwork displays common bond brick with concrete mortar. Interior walls exhibit fire brick on all surfaces that were exposed to heat. The interior boiler wall is doubled walled with a row of air spaces with brick headers along the base, possibly to prevent cracking.

Photo No. 0013. Power Plant (11), view to southeast

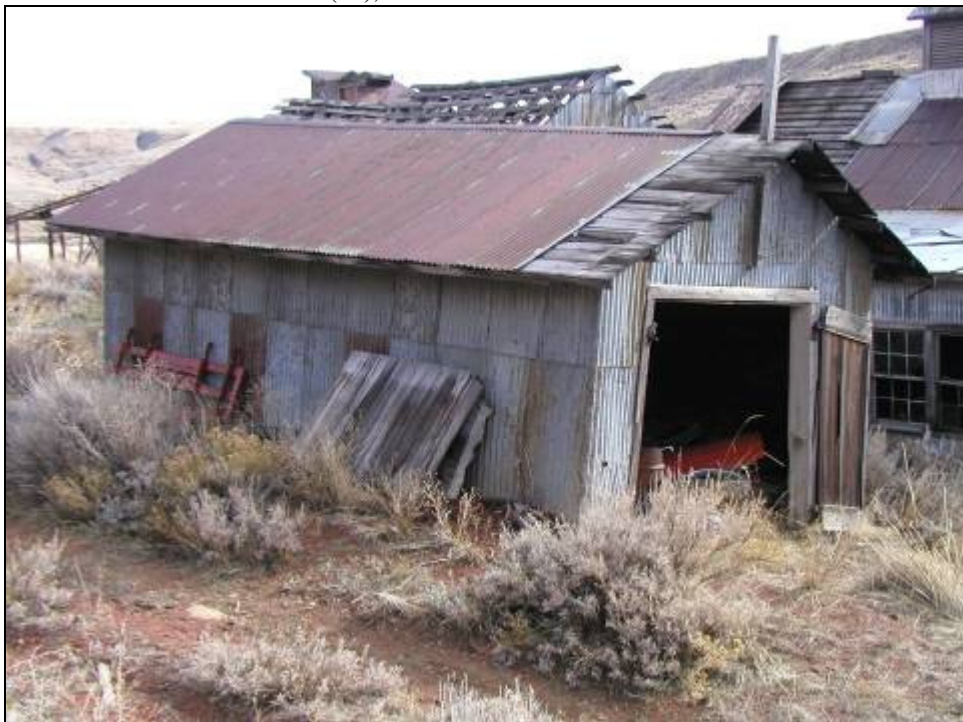
This garage is located adjacent to blacksmith and repair shop (Building 13). The garage is a wood frame rectangular building that measures 24' x 14'. It is oriented east and west and faces west. The bay entry is central to the façade with one of the two wood doors still hanging from its hinges. A gable roof with exposed rafters and walls sheathed in corrugated metal covers the building. Much of the corrugated metal on the roof is missing revealing the wood decking underneath. There was no discernable foundation.

Photo No. 0014. Garage (12), view to southeast

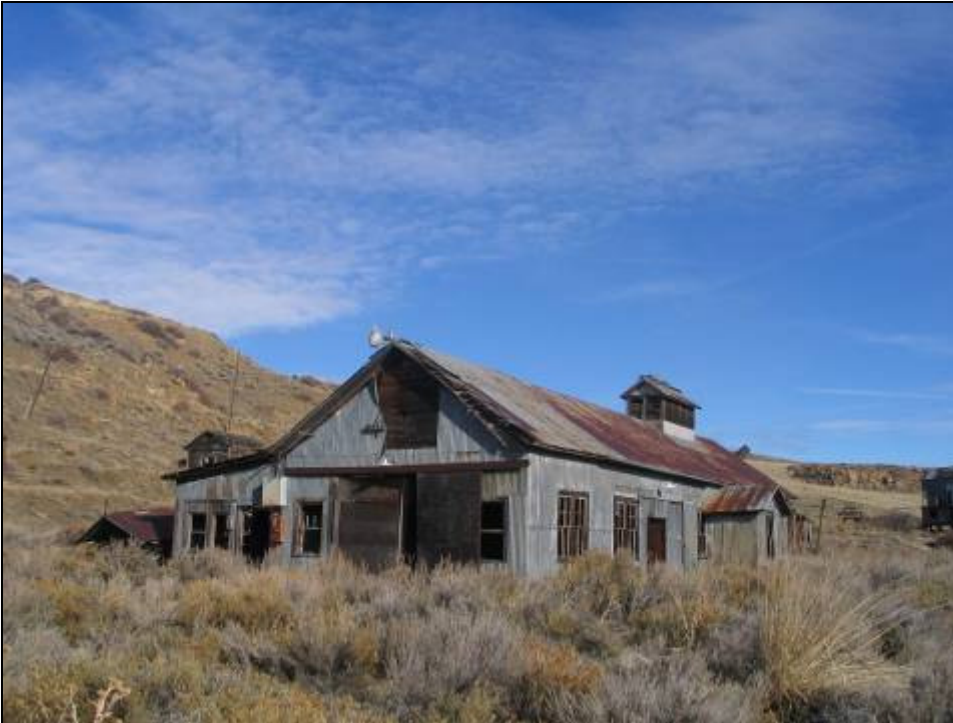
The blacksmith and repair shop and geology assay lab was constructed in 1912 and expanded in 1928. The boiler building attached to the east end of the building was built in 1932. The wood frame building rests on a concrete pad foundation. The building measures

49' x 154.' It has a rectangular plan covered by a gable roof; both the roof and the walls are clad in corrugated metal. Loft entries are located on both east and west gable-ends. A gable-roofed cupola is centrally located on the roof of the building straddling the gable ridge. The cupola has wood louvers on all sides. Windows throughout the main building are four-light casements except where noted; the glass has been broken out of all of them. Windows on the south side of the building are single, paired and tripled openings. A gable-roof vestibule that probably functioned as an office is centrally located on the south elevation of the building. It rests on a concrete pad foundation and has a window opening on the south side. The gable roof and walls are clad in corrugated metal and the structure is only accessible from the interior of the main building. A bay entry with double doors is located on the west of the south side.

A gable-roof addition is off-set to the north on the east end of the building. The addition housed the boilers for the machine shop. The walls are clad in corrugated metal, while the badly deteriorated roof consists primarily of exposed wood decking and rafters. An entry on the east of the south wall of the addition has a modern wood hollow-core door. A horizontally-oriented window opening is located next to the entry to the west. Windows throughout the addition are four-over-four double-hung casement units. The remains of a 4-light casement window are centrally located on the east side of the addition.

The east end of the building houses the boilers and furnaces used for the blacksmith and repair processes and installed in 1932. They are still located in the building. The largest boiler reads ERIE CITY IRON WORKS/ERIE PA/40 E on its north end. The boiler display Morrison boiler tubes. Entries lead to both boilers and both have vertical board doors. The steel smokestacks associated with the boilers still pierce the roof and are in various stages of collapse. A pressure release pipe is extended to the southeast off the southeast corner of the building.

Photo No. 0015. Blacksmith and Repair Shop (13), view to northwest

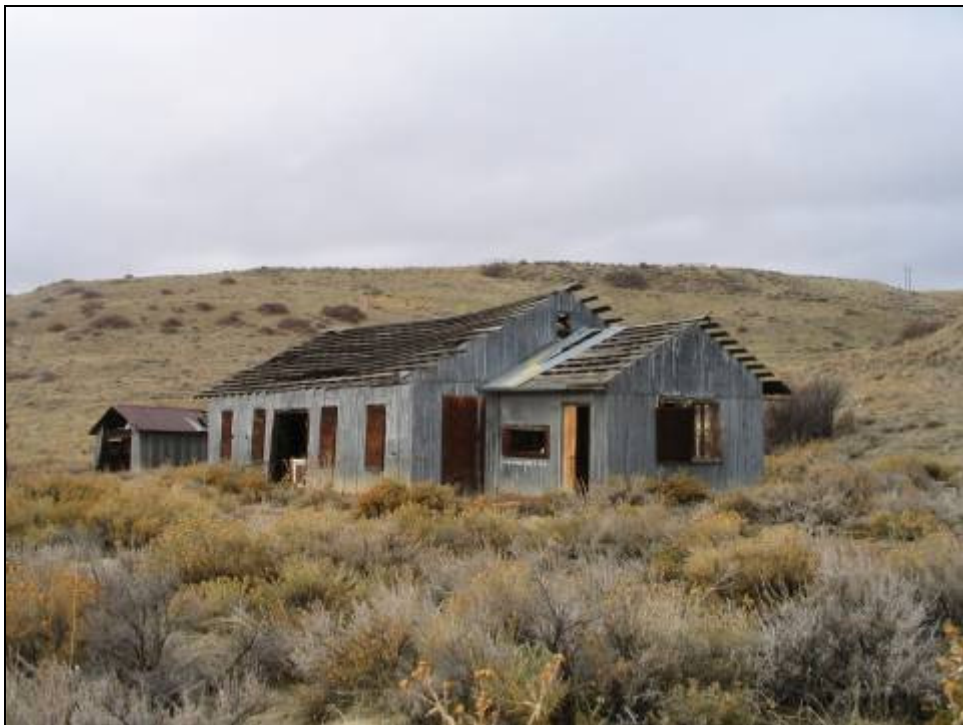
This building is believed to be Carpenter Shop #2 that was constructed in 1914. It is a wood frame, supply storage building. It is oriented east and west and faces south. It has a rectangular plan (36' x 62') and is covered by a gable roof with loft openings in the gable-ends. The corrugated metal and decking that once comprised the roof is mostly gone exposing the roof joists and rafters. The building has exposed rafters on the eaves. The walls are clad in corrugated metal. The building rests on a concrete pier foundation.

Windows throughout were one-over-one double-hung though all have been boarded over. A bay entry that once held a double door is centrally located on the south façade. The entry is flanked by two window openings on each side. There are no window openings on the rear (north) façade of the building. A window opening is centrally located in the south of the west wall. A gable-roof addition is attached to the east wall of the building. The addition rests on a concrete foundation and the roof and walls are clad in corrugated metal. An entry is located on the right of the south façade of the addition; it has a modern hollow-core door. A horizontal window opening is located left of the entry. Paired one-over-one double hung windows are centrally located on the east wall of the addition; the left (south) unit is partially boarded-over. There are no window openings on the rear (north) façade of the addition.

Photo No. 0017. Parts and Supply Building (15), view to west

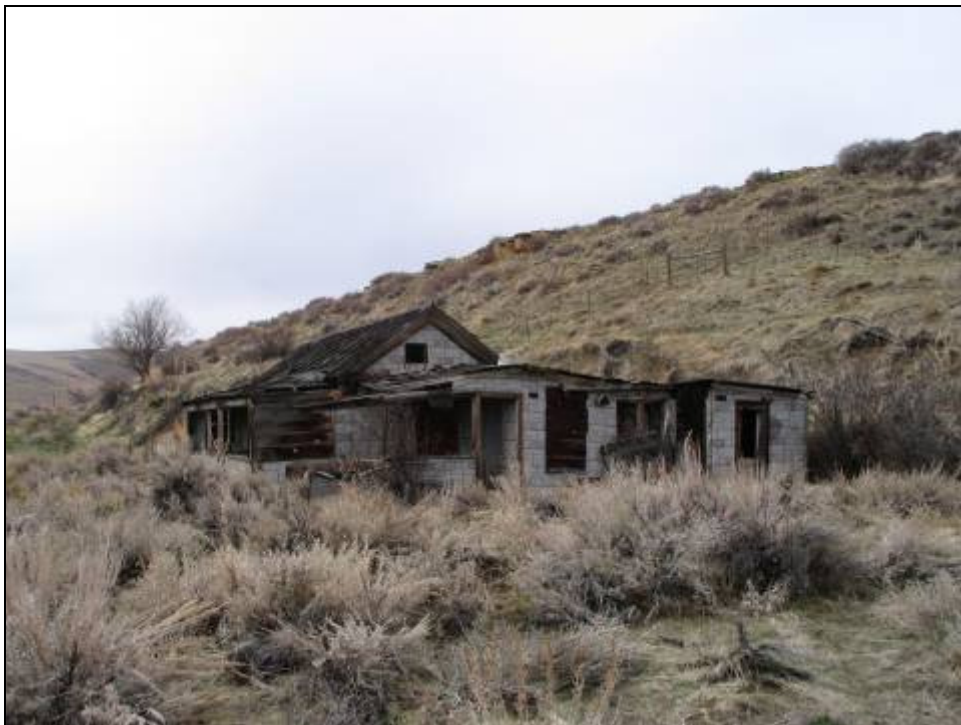
The residence consists of a core section and an addition on the north. It faces east toward the mine buildings. The property is badly deteriorated with the roof partially collapsed. The No-Style core residence has a gable roof that is badly deteriorated with the remains of wood shingles on the south side of the gable and rolled asphalt on the north side of the gable. Corniced fascia is located under the eaves of the east and west gable ends as are attic entries. The front and rear façade of the core section is clad in asphalt siding manufactured to mimic random ashlar pattern. It covers the original novelty siding.

An open-air porch is attached to the façade of the core and the adjacent addition. It has a low-pitched gable roof. The roof is badly deteriorated with much of the underlying decking exposed to the elements. The roof is supported by square posts and is partially enclosed by a low wall that is clad in asphalt siding. The porch shelters a window opening that is central to the core façade. Access to the porch is off-set to the north of the façade.

A large shed roof addition is attached to the north side of the residence and is partially built into the hillside on the north. Its roof is badly deteriorated with much of the decking collapsed into the interior of the addition. A wood paneled door entry on the addition faces south and opens onto the façade porch. The walls of the addition on the east and west facades are clad in asphalt siding. The addition has been extended on the northeast corner of the structure. It has an entry that opens to the east and holds a wood paneled door that once included a now-missing single fixed light. There are three window openings on the façade of the addition; all are boarded-over.

A root cellar is dug into the hillside on the north. The cellar had concrete walls and a concrete roof. The roof has been exposed and is badly deteriorated.

Photo No. 0023. Cameron House and Garage (21), view to west

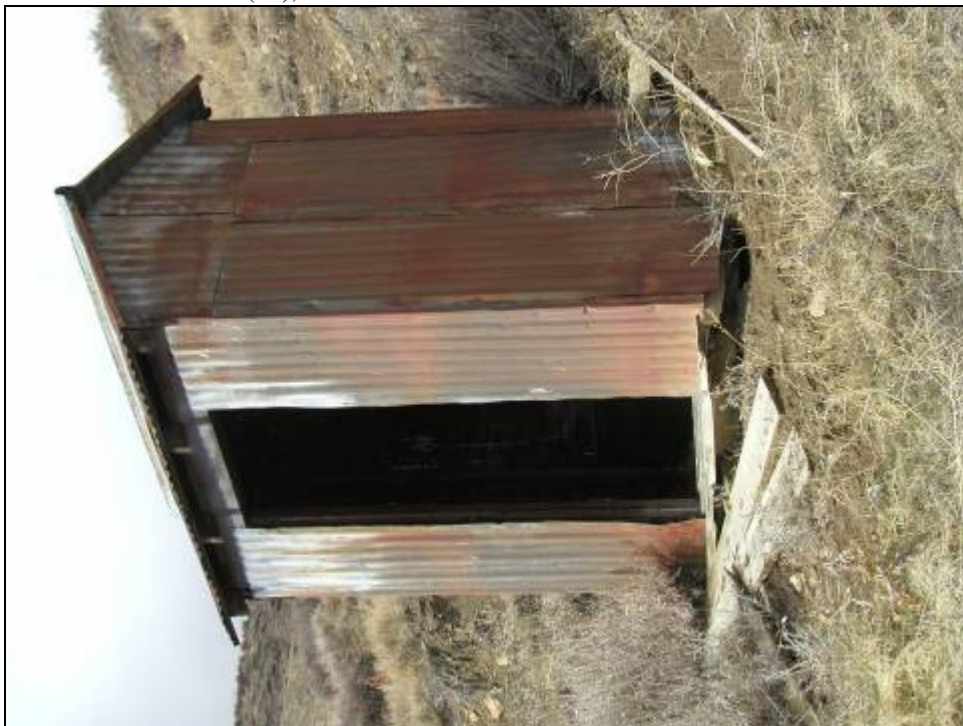
This two-seater wood frame outhouse is located on a side hill above the blacksmith and repair shop (Building 13). The outhouse sits on wood beams, indicating it was moved to this location, presumably from somewhere else within the complex. All walls and the roof are covered with corrugated metal. Its gable roof has exposed rafters and a metal ridge cap. The entrance is centered on the south wall but the door is missing. The interior of the outhouse has redwood walls and a wood floor.

Photo No. 0026. Outhouse (24), view to northwest

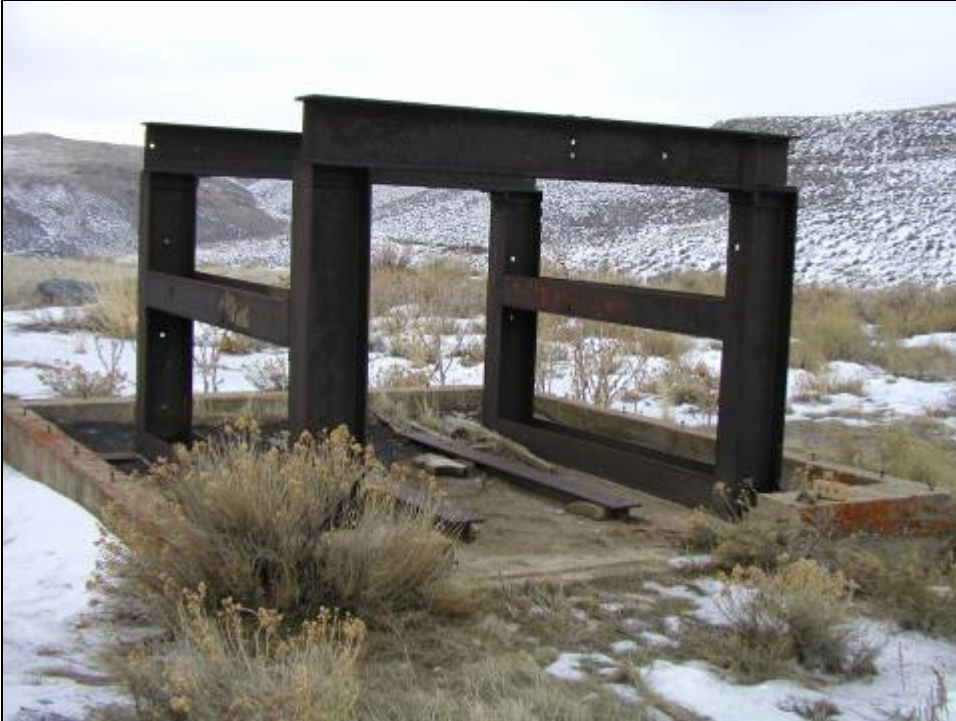
This steel frame structure stands northeast of the tippie (Building 4). It is constructed of heavy steel I-beam members and measures 18' x 16'. The structure stands within a concrete foundation with 12' high walls and an opening to the south. This structure has an unknown function.

Photo No. 0029. Steel Frame Structure (27), view to north/northeast
